MacLeod Consulting, Inc.

Re: Condition Assessment, Proposed Library
29 North Avenue Reuse

At your request, I surveyed the structural condition of the St. Michael Church property at 29 North Avenue, Mendon. The purpose of the survey is to assess the buildings for reuse as a proposed renovation to a public library and town offices.

St Michael's Church Mendon
Structural Condition Assessment

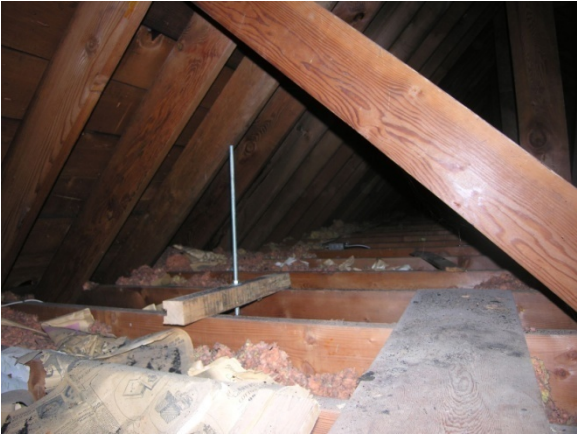
Work on this building would likely fall into a Level Two scope. The building presently relies on the interaction between roof truss frames and the exterior walls for lateral stability. For this Level Two scope, wind loading would apply a greater lateral load than would earthquake loading. The walls would be overstressed in a full code wind loading requirement and lead to cracking and possibly instability. I calculated these flexural stresses in the order of 150 psi (analysis 1 and 2) at the base of the wall which exceed 19 psi permitted for this type of construction. The associated movement at the eave is small, 0.15 inches (uncracked). The stability in the walls can be mitigated by developing a diaphragm in the attic crawl space spanning side to side from front to rear tying the roof framing to the front and rear masonry walls.

6. Roof framing over sanctuary

1. Attic diaphragm. Install a plywood diaphragm on the ceiling joists over the sanctuary from side to side and end to end. Include two layers 2 by 8 continuous around the border to tie the edges together. Anchor to the end CMU walls with hollow wall renovation anchors. Alternatively build a diaphragm horizontal truss on the joists to serve the same purpose.

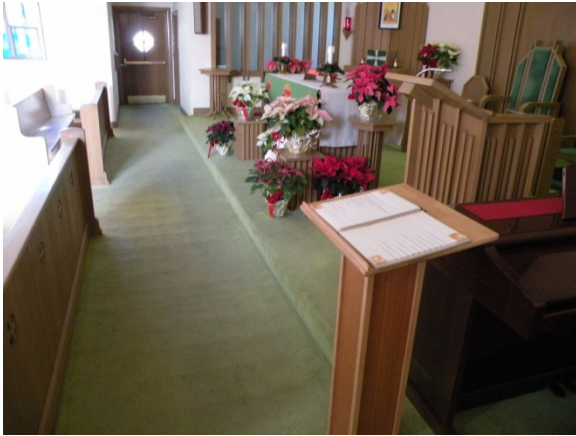
Much of the visible framing agrees with that shown on the original plans. Some alterations are not shown on plans. For instance, the organ located among the pews is sunken into the floor (photo 8), and the raised platform at the altar has a layout not shown on plans (photo 7; sketch 1). The 1987 alterations show folding partitions added in the basement (photo 13). These agree with the renovations plans.

7. Raised floor at altar

The altar area is on an elevated platform. It may be raised off a structural floor or it may be framed one step up. I could not determine from my survey or review of the drawings. Plan on demolishing this raised floor and applying a subfloor and finish floor to the framing.

2. Sunken floor. Remove the sunken joist framing beneath the organ and reframe the floor with joists matching the original framing.
3. Raised floor. Demolish the raised floor. Lay down a subfloor underlayment and finish with flooring or carpet to suit the program.
4. Interior stairs. Demolish the concrete winder stairs. Re-layout new concrete stairs with acceptable rise to run and acceptable treads and landings.
5. Exterior stair railings. At a minimum re-anchor stair railings at the side exit. Otherwise replace the railings.
6. Exterior stair treads. Cut out cracked stair treads removing weak material. Apply bonding agents and stainless steel/galvanized dowel reinforcement. Recast treads.
7. Drain pipe. Lower the drain pipe into the floor. Adjust local joist framing and patch the flooring.

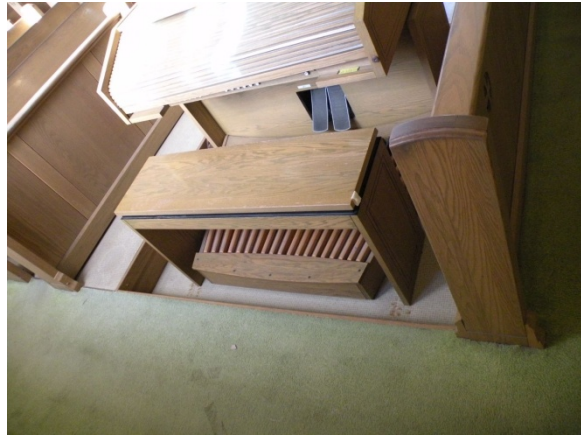
8. Sunken floor at organ

The floor at the sunken organ is too low. Plan on reframing it.

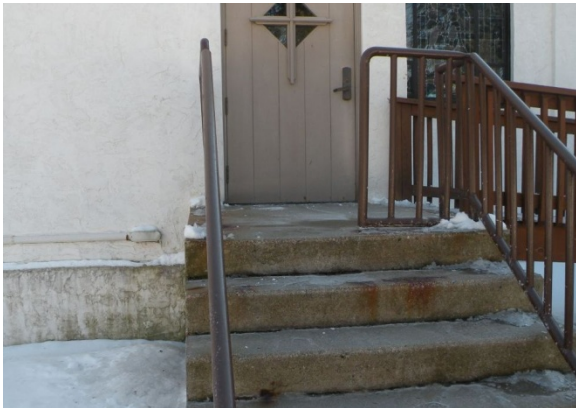
I did see some anomalies that may require minor structural framing changes to accommodate improvements. These are as follows: A drain pipe is covered with a step in the choir room (photo 12). Stairs to the basement at the front side entry are steep (8 inch rise on 11 inch run) and have nonconforming winders (photo 11). Exterior stair railings at the side entry are leaning (photo 9). Some railing posts are not anchored. Several concrete stair treads are cracked (photo 10).

Exterior landing railings are bent. These are inadequately anchored. Plan on reinstalling railings.

9. Displaced railings at side entry

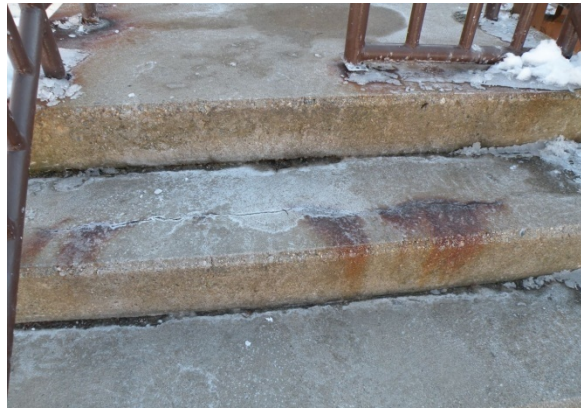
10. Cracked stair treads at side entry

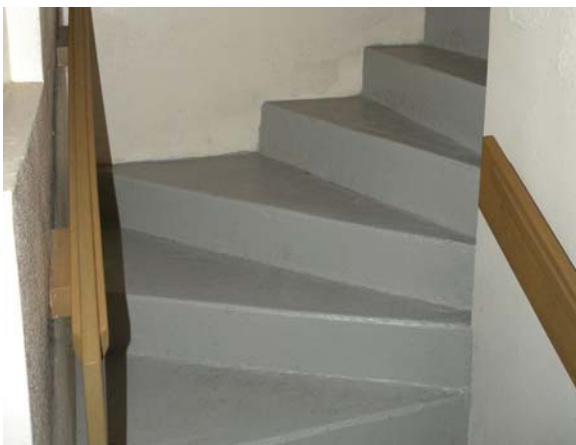
The front interior stairs to the basement are an 8-inch rise to an 11-inch run, steeper than permitted by code. These same stairs have a winder which is not permitted under the modern code. Plan on rebuilding this stairway.

11. Stair winders to basement

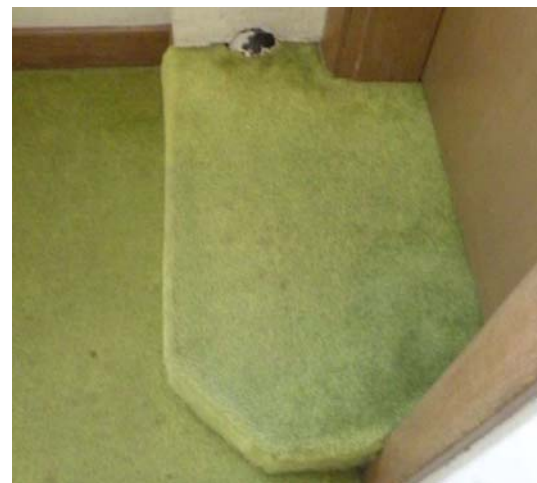
A drain pipe protrudes into the floor area in the basement women's room. This could be reset below the floor to remove the step for a new room layout.

12. Step covering drain pipe in choir room

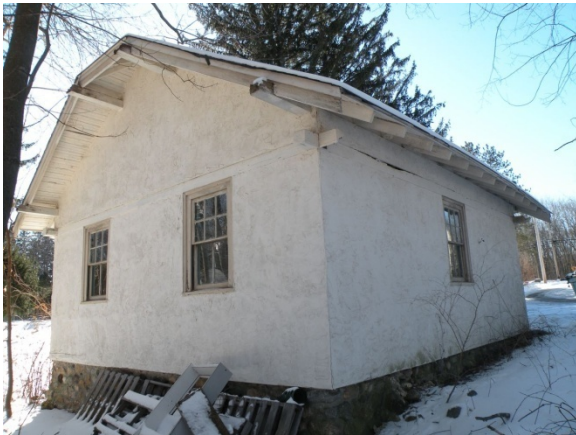
The detached garage is presently used to store furniture and theatrical props. It is congested making a thorough survey difficult (photo 17). The floor is finished with vinyl tile suggesting the structure served other than as a garage. I did see items stored in the loft (photo 18). The loft does not appear designed as a load carrying attic. The wood framed exterior walls are close to grade making them susceptible to infestation. I did smell mildew which may indicate the presence of decay causing organisms in the structure. Roof purlins extending out of the gable walls have rotted ends (photo 16). I saw a gap high up in the north wall (photo 15).

15. Rear view of separated garage

1. Repair rotted purlin ends. Consolidate and patch eight ends of purlins using borax based preservatives and epoxy patching systems.
2. Repair opening in wall. Open and patch exterior stucco finishes to access concealed framing to patch opening under eave.
3. Repair sills. Open and patch exterior stucco finishes to access concealed framing along sills of walls. Cut out rotted wood and splice studs. Add preservative pressure treated wood to replace sills. This is an allowance as the extent of deterioration is unknown.

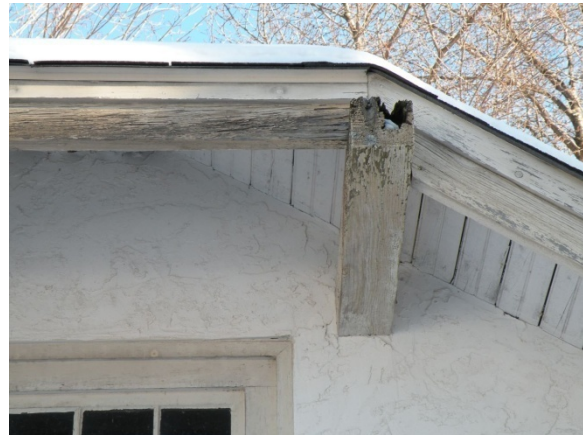
The loft is accessible through a trap door accessed by a temporary ladder. This would indicate it was not intended for storage. Given the wear from storage in the loft, the presence of mildew, and some minor rot at the ends of roof purlins suggests some moderate amount of decay may be concealed within the walls especially near the foundation sills which are close to the ground. Expect some structural repairs to maintain this garage in its present use.

16. Rotted roof purlin ends

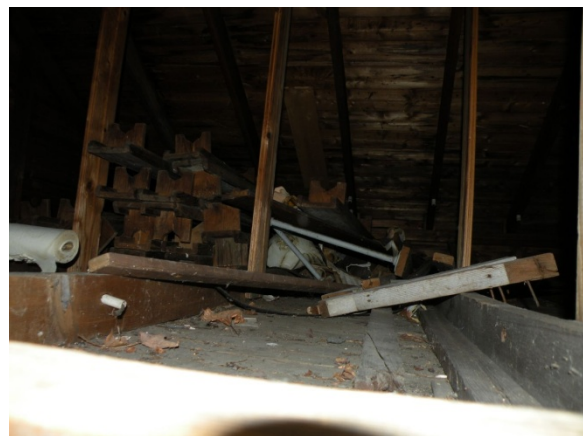
18. Loft in separated garage

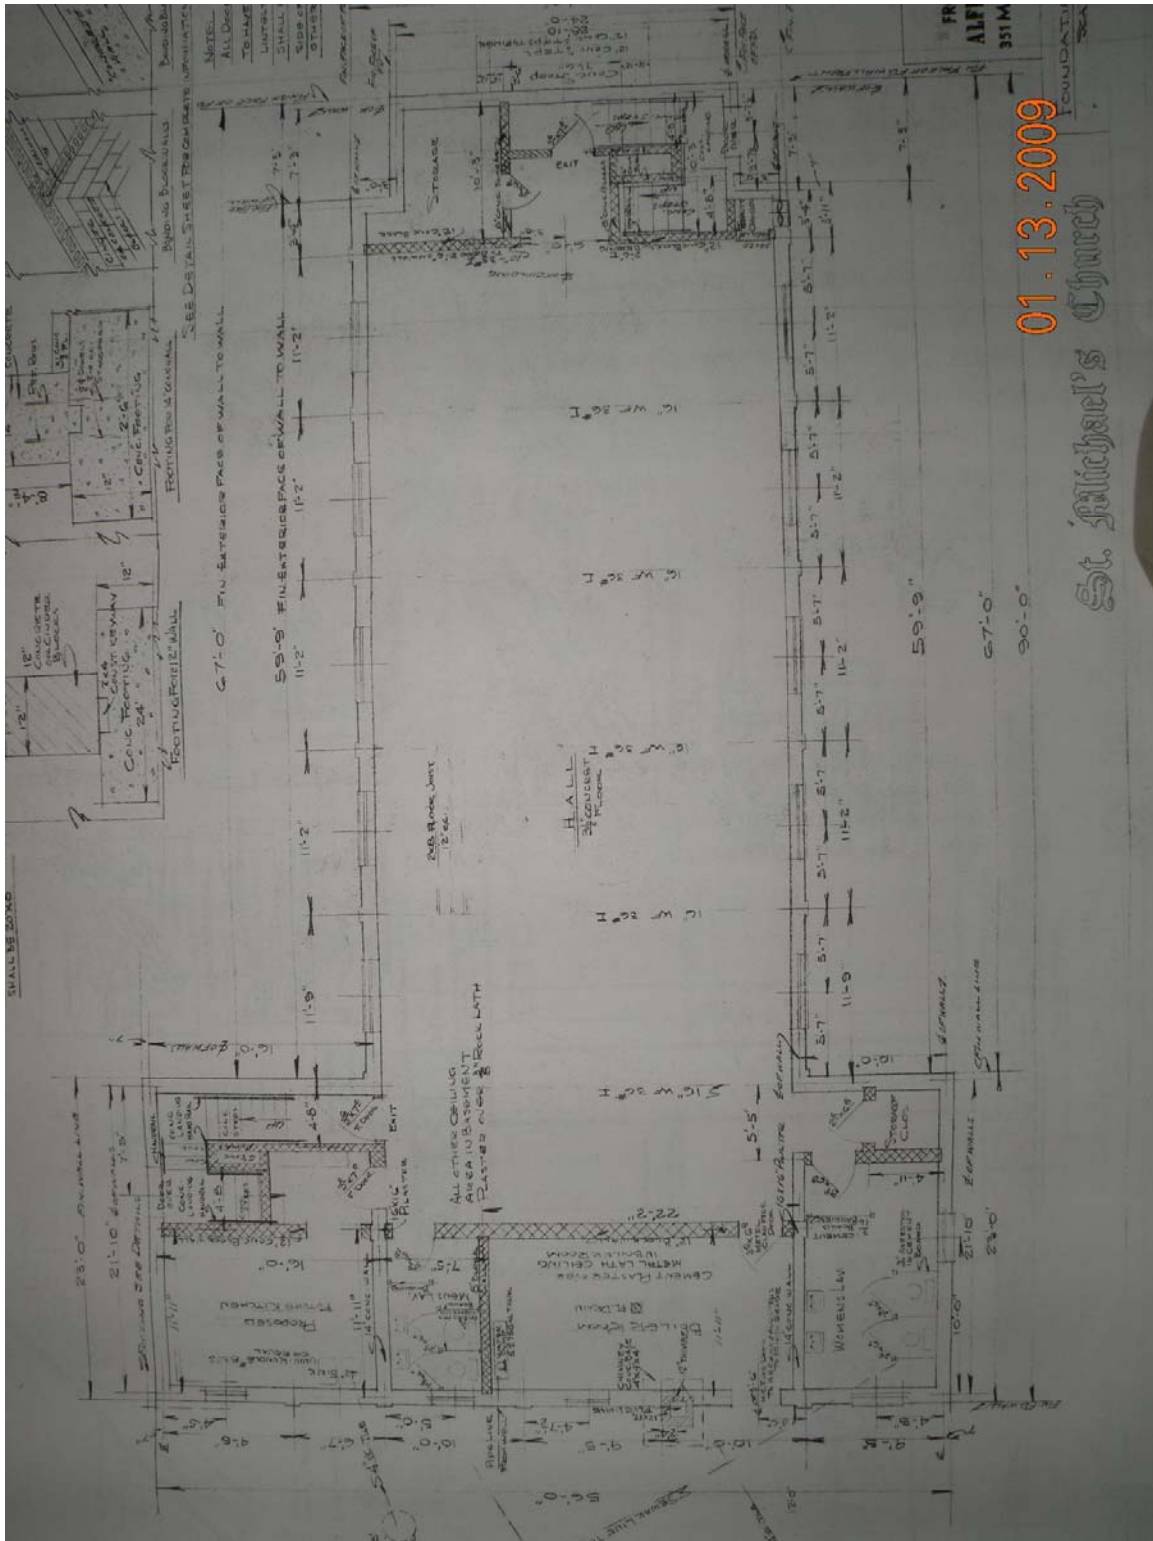
Church first floor framing superimposed on basement plan

The first floor has the capacity to carry a live load of 60 psf which is the code requirement for library reading rooms. The framing is indicated on the original basement plan (sketch 1). Such rooms can accommodate the shorter book shelves in modern library design.
