## Re: Lake Nipmuc, Mendon, MA – 2025 Year End Report – DEP File #218-0867

#### **Summary Of 2025 Management Activities**

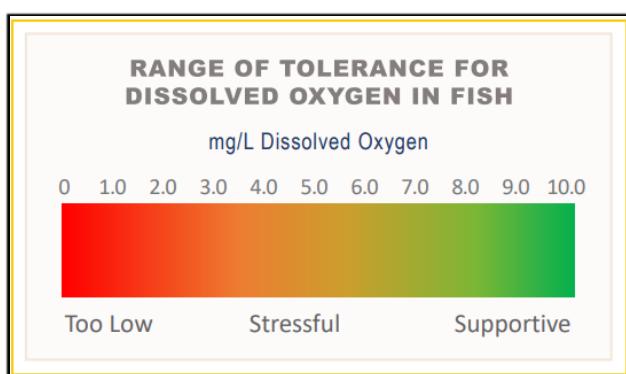
Figure 2: Dissolved Oxygen Table

Dissolved oxygen is the amount of oxygen in water that is available to aquatic organisms. DO is necessary to support fish spawning, growth, and activity. Tolerance varies by species, but the figure shown provides a general range of fish tolerance (Source: [epa.gov](http://epa.gov)). Dissolved oxygen can be affected by many outside factors, such as: temperature, time of day, and pollution. Dissolved oxygen levels are typically lowest early in the morning. Healthy water should generally have concentrations of about 6.5-8+ mg/L (see Figure 2). Water clarity was also assessed using a Secchi

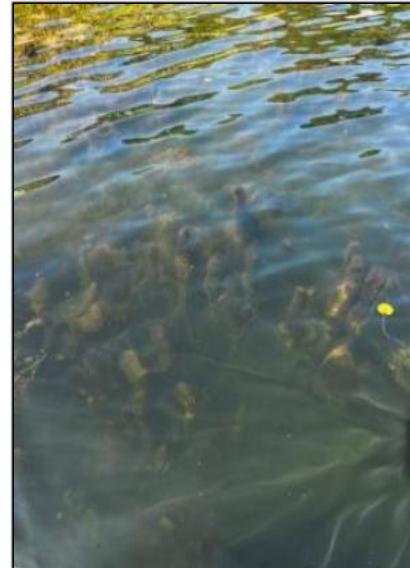
Figure 3: Variable milfoil prior to treatment during August 7<sup>th</sup> visit

The purpose of this visit to Lake Nipmuc was to complete an herbicide treatment for the curbing of any prevailing variable milfoil within the

waterbody. A brief survey and the collection of basic water quality data were also carried out. The target areas for this treatment were the northern, northwestern, and southwestern coves where pondweed densities were at their highest. Overall, the treatment was conducted successfully, and excellent coverage was achieved via jon boat within the target areas listed above. Scarce densities of water

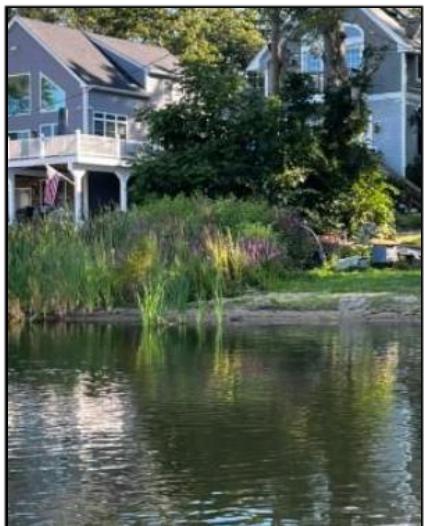
Figure 4: Purple loosestrife plants during the August 22<sup>nd</sup> visit

This site visit consisted of a survey of the shoreline and a purple loosestrife treatment. The survey was conducted in order to assess the extent of the purple loosestrife population and to

determine treatment areas. The purple loosestrife was most dense around the northern cove and on the peninsula. There were also scattered patches of purple loosestrife along the entire shoreline that were treated when observed. Some plants were hand pulled if easily accessible. The prior treatment for pondweed growth appeared to have been effective as the pondweed densities were lower or eliminated in the target areas. Water clarity was good and dissolved oxygen readings maintained healthy levels. Overall, the visit went well, and the treatment was successful at targeting purple loosestrife. The liquid contact herbicide was applied using a treatment boat and a low volume backpack sprayer. This application methodology allows for even coverage within the treatment areas and the ability to be selective in targeting the purple loosestrife.

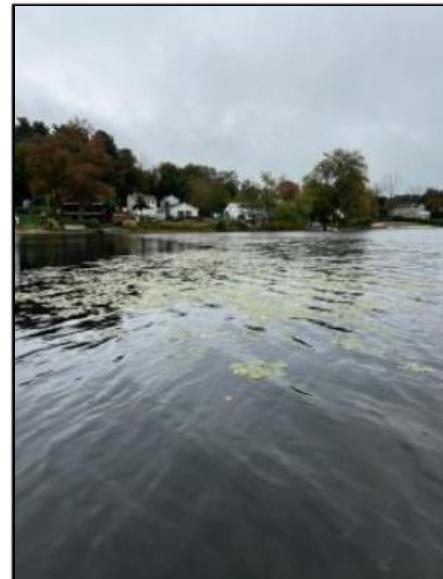
time of the visit. Bushy pondweed and tape grass (*Vallisneria americana*) were observed in the northeastern cove, along the western shoreline, and in portions of the eastern shoreline; however, populations remained below nuisance densities. Purple loosestrife along the shoreline was dead, consistent with effective prior treatment. Scattered patches of waterlilies (*Nymphaeaceae*) were noted around the shoreline, with watershield (*Brasenia schreberi*) present in the southeastern cove. A few bladderwort (*Utricularia* sp.) fragments were documented in the southwestern end of the pond. Spiny naiad (*Najas marina*) fragments were observed floating along the eastern shoreline, with rooted plants present in the southeastern cove. Small patches of variable milfoil regrowth were also observed at the southern end of the pond. A microscopic algae bloom was evident across much of the southern half of the pond, characterized by a green tint and fine particulate material in the water column. Overall, treatments conducted earlier in the season targeting variable milfoil, bushy pondweed, and purple loosestrife were effective, with significantly reduced densities of these species observed during the survey.

Figure 5: Water and Wetland conducting a post-treatment survey

Looking ahead to 2026, we recommend maintaining a proactive, monitoring-based management program supported by early-season surveys to guide herbicide timing and treatment coverage. Diquat remains the preferred herbicide for controlling both variable milfoil, bushy pondweed, and/or spiny naiad, given its proven effectiveness and cost efficiency. Since diquat provides only seasonal control, an early-summer application should again be performed to maintain open-water conditions and reduce biomass buildup.

We also recommend ongoing shoreline monitoring and selective treatment of purple loosestrife to prevent recolonization. Native waterlilies should continue to be observed but do not currently require management intervention. Continued collection of basic water quality data during site visits will remain valuable for tracking long-term ecological trends.
