## FIELD NOTES SUMMARY

**Customer:** Town of Mendon

**Pond Name:** Lake Nipmuc

**Date:** 5/24/24

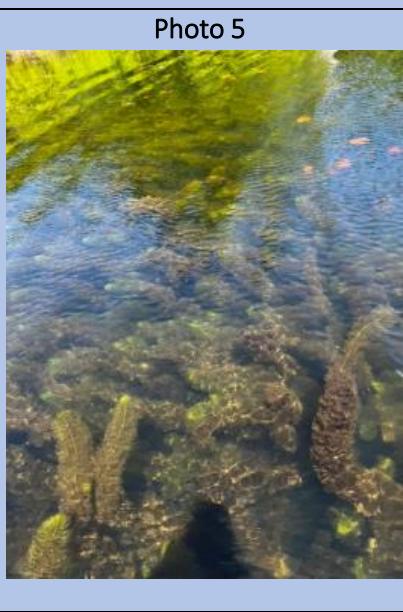
This visited consisted of a survey of Lake Nipmuc. Invasive variable milfoil was found in the typical areas consisting of the old Nipmuc Marina, the shallow cove near Alicante Restaurant, and the southwestern cove near the outlet. The milfoil was dense (best seen in photo 5 below). Tapegrass, bladderwort, and waterlilies were found in sparse densities throughout the lake. The water clarity was excellent as demonstrated by the high Secchi depth (above). There were no signs of an algal bloom. A small film of pollen was documented across the surface near the shorelines. This is not to be confused with algae.

Based on this survey, we will schedule the June treatment for the control of invasive variable milfoil.
